# TOWN OF BILLERICA, MA STORMWATER ASSET MANAGEMENT PLAN

**April 2024**

# OBJECTIVES

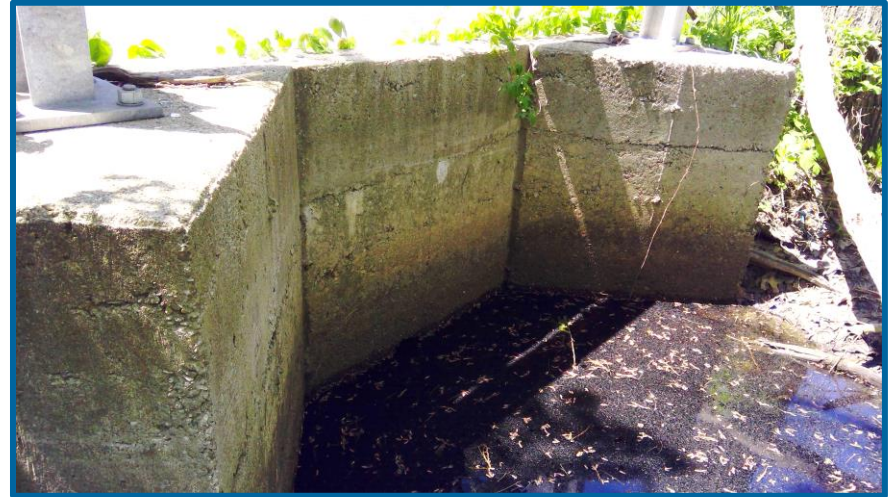
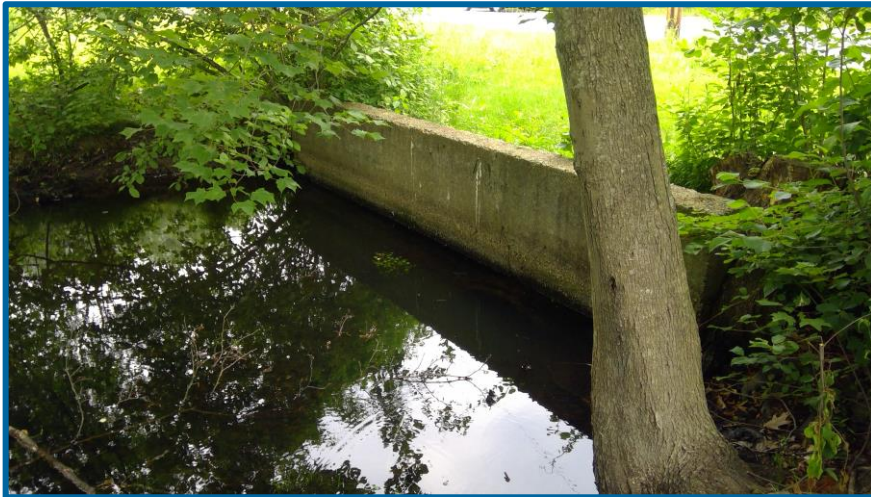
25 culverts were found to be submerged at the inlet and/or outlet of the culvert

Indicates there may be a hydraulic restriction within the stream reach and/or beaver dam impacts

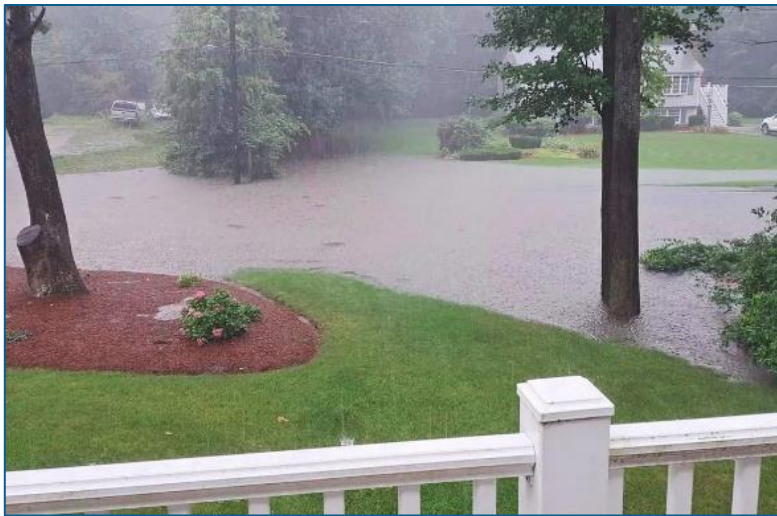
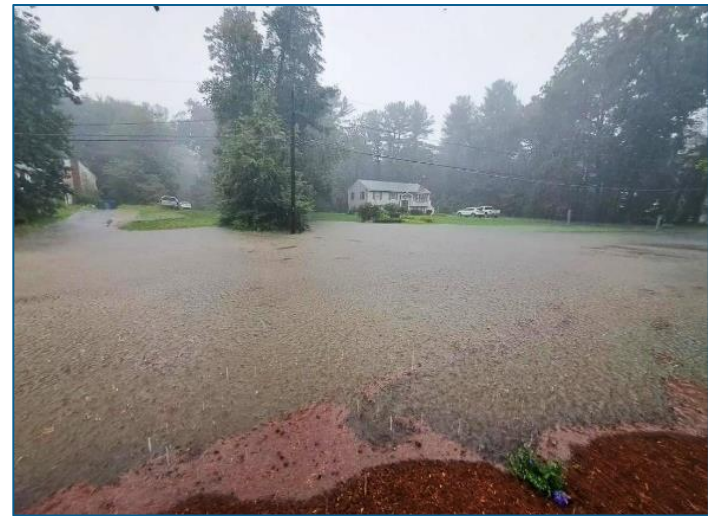
Severity of flooding on Shane Lane during a storm on August 8, 2023

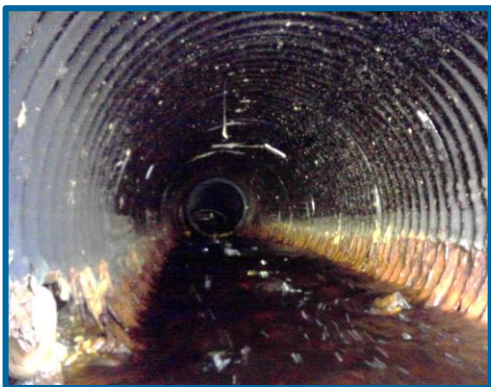
10 culverts changed material between inlet and outlet, which poses additional challenges to its structural integrity.

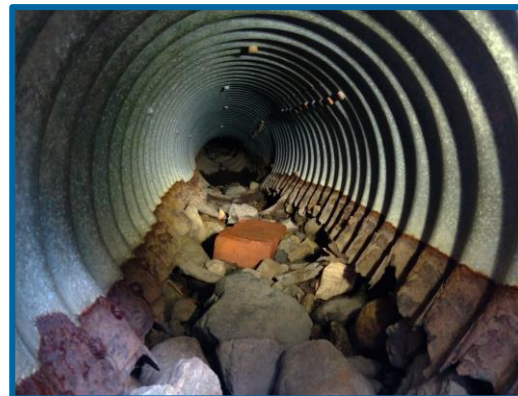
Corrugated metal pipes (CMP) are deteriorating. CMP made up 34% of the town's assessed culverts.

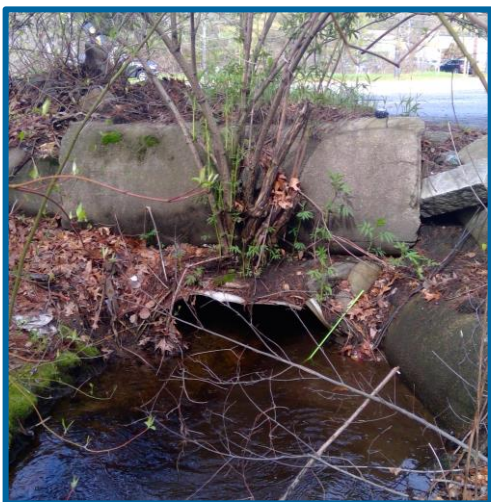
22 culverts had a tree present near the upstream and/or downstream headwall/wingwall. These may cause damage to the structure and should be removed as applicable.

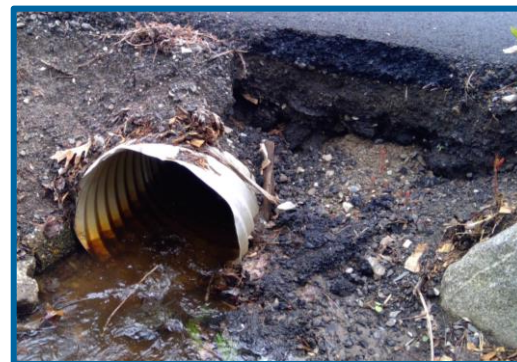
Poor or critical roadway embankment conditions were noted at 58 upstream locations and 47 downstream conditions.
