# TOWN OF BILLERICA, MA STORMWATER ASSET MANAGEMENT PLAN

**April 2024**

# OBJECTIVES

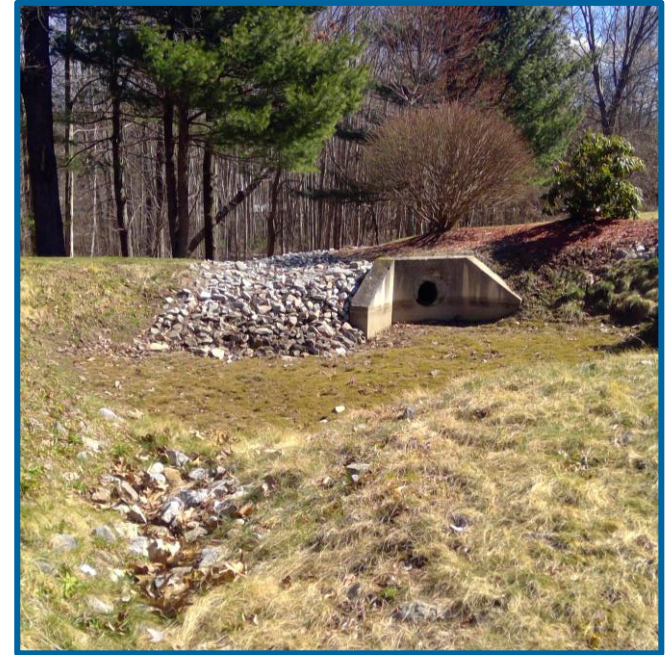
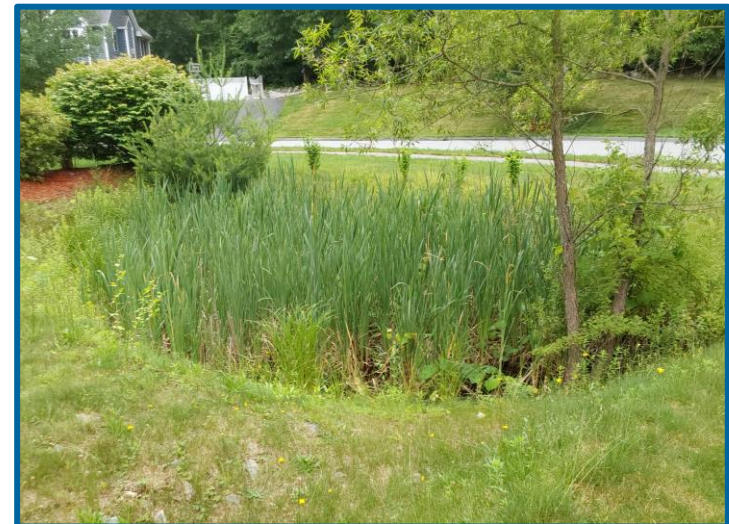
- **What is a stormwater best management practice (BMP)?**  
Click [here](#) to learn more!
- **Assessments of Town-owned BMPs were completed during AMP time period (2022, 2023)**
  - Noted BMP type
  - Condition of BMP components
  - Maintenance concerns (trash, overgrown vegetation, excess sediment)
- **Takeaways**
  - Make targeted repairs
  - Conduct general routine maintenance

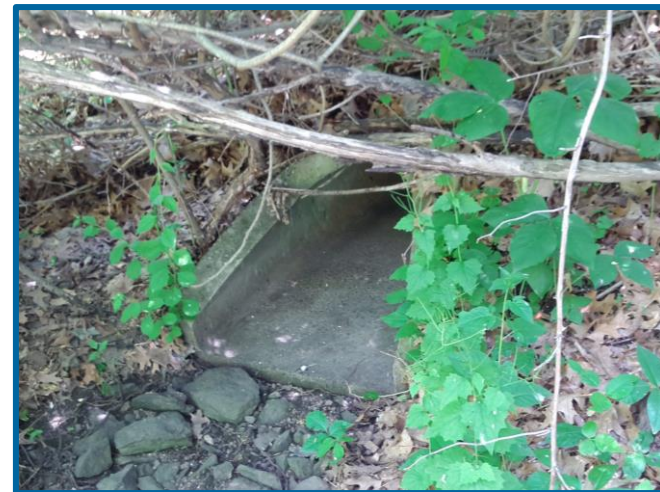
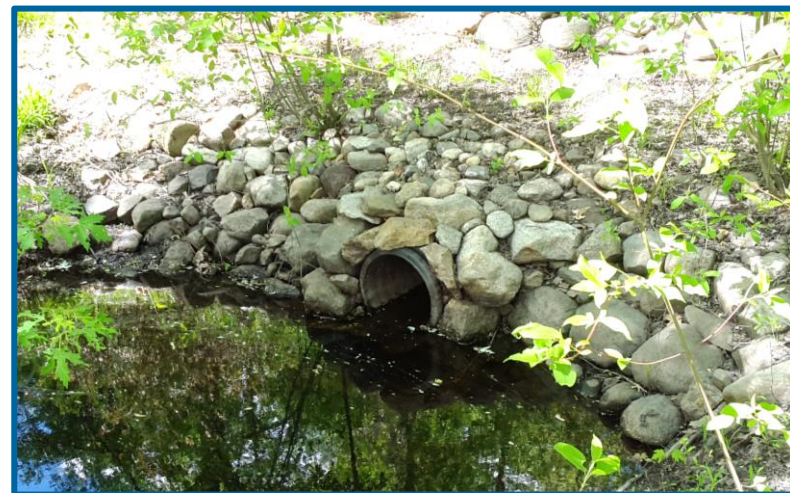
- **Outfall:** stormwater discharge structure
- **Dry weather inspections of Town-owned outfalls have been completed over the past five years**
  - Noted outfall type
  - Pipe condition
  - Maintenance concerns (overgrown vegetation, excess sediment)
- **Takeaways**
  - Conduct general routine maintenance and repairs
  - Continue to inspect newly mapped Town-owned outfalls

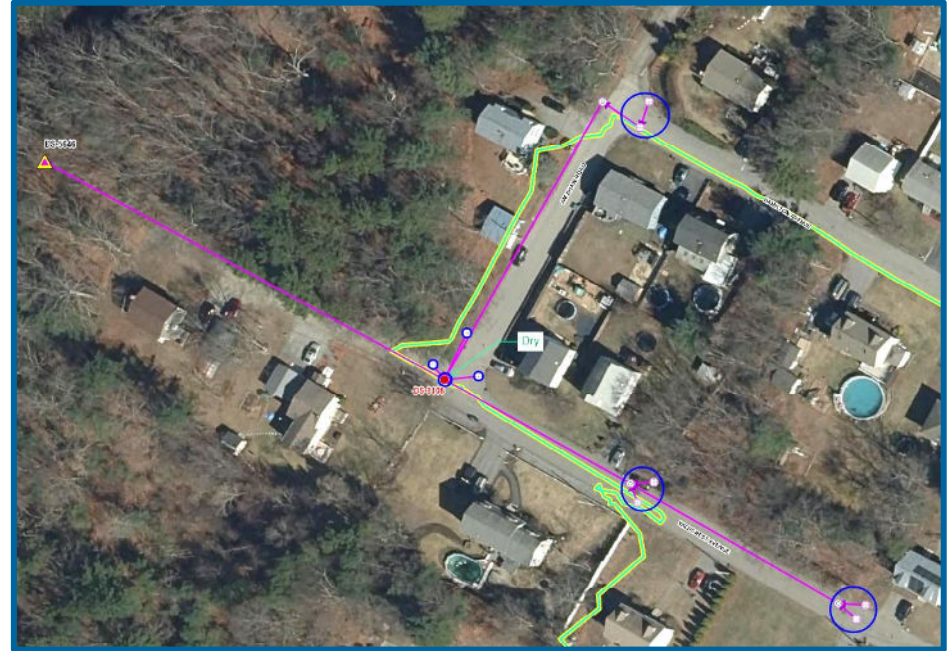
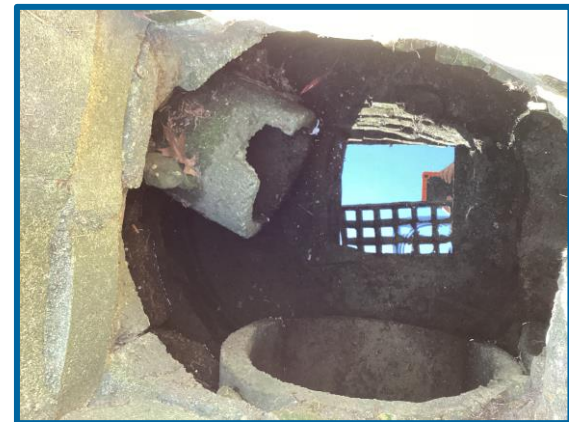
While there is more work to be done under the Catchment Investigations program, there were no initial indications of illegal discharges to the drainage system in the investigation areas.

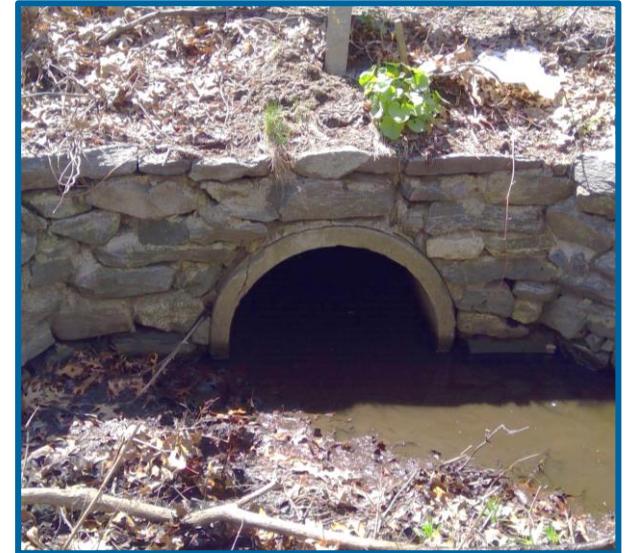
- **223 Town culverts identified and assessed**
- **Used NAACC protocol to evaluate condition and aquatic passability**
  - An accepted standard for evaluating risk of failure and other environmental considerations
  - Noted culvert size and material
  - Structural condition of culvert, headwall, roadway
  - Maintenance concerns
